Quest Engineering & Failure Analysis, Inc.
www.quest-engineering.com

Re: FR26 Report

File: Bryson Accident
Quest No: 10519

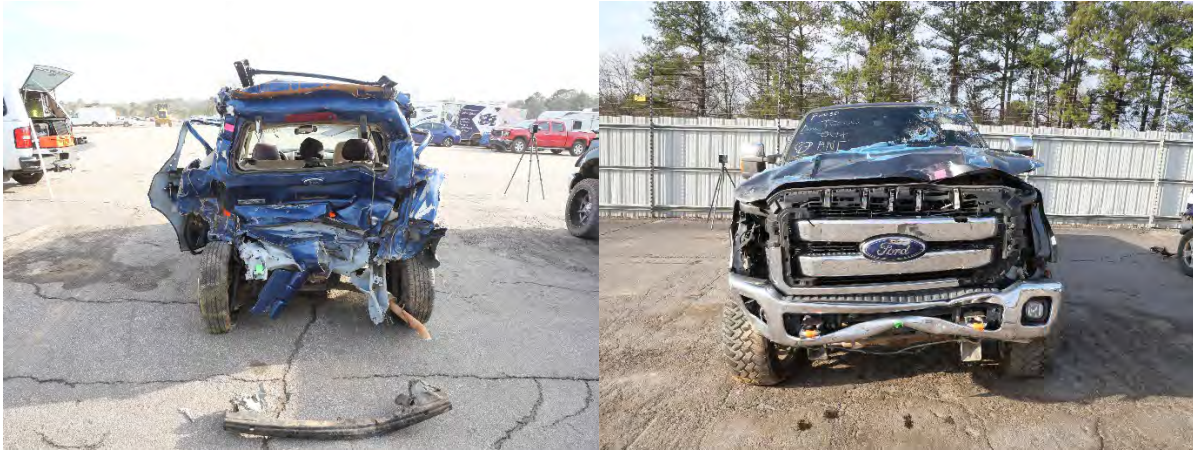
The initial effort in accident reconstruction is the documentation and preservation of evidence, where areas of the vehicle that recorded information about the crash are examined, such as crush, paint transfer, and characteristic damage and markings. Several "match points" were identified on each vehicle, which are unique characteristic marks that correspond to unique components or geometry of the vehicles. Marking the match points with different colored bright tape allowed for the correlation of vehicle-to-vehicle damage (*Figure 1*). The match points on each vehicle were carefully measured and photographed. Similar efforts were expended at the accident scene.

Figure 1: Match points with brightly colored tape

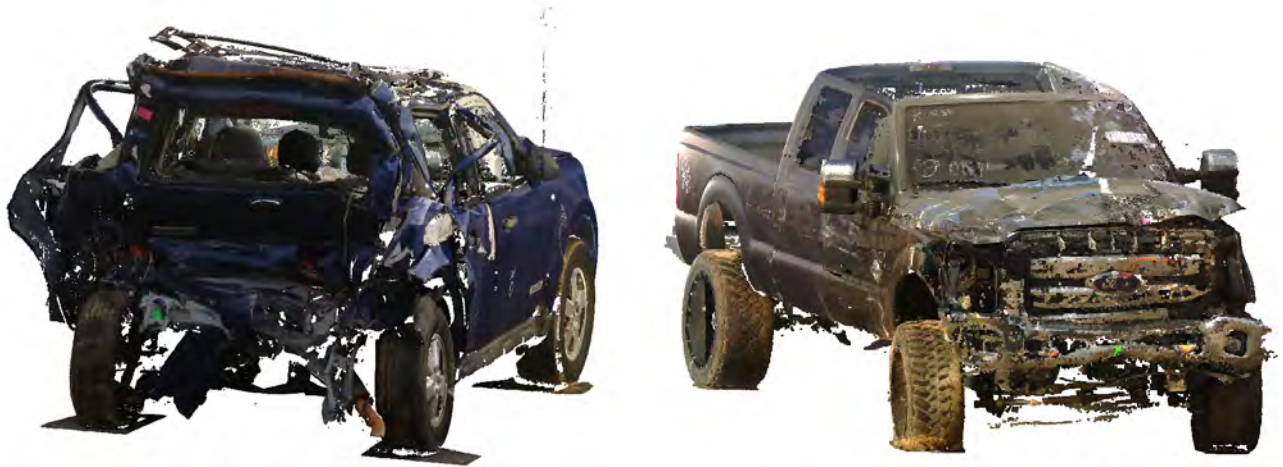
Figure 2: Brightly colored tape visible on the point cloud models

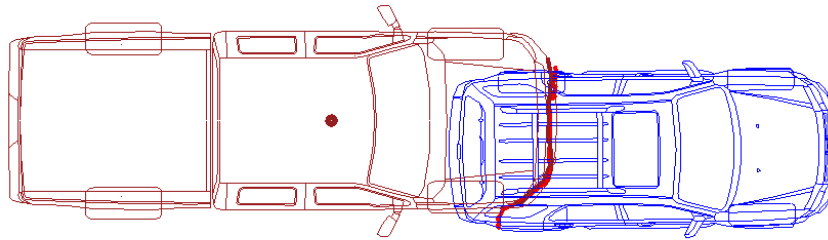
The point clouds from the inspections were imported into a CAD software called AutoCAD. In this software, a cross section of a scan can be created at any desired height level, such as the crush region. The crushed region of the Escape was around the bottom of the rear hatch and the F250 crush region was at the bumper level height. The cross section was then viewed in an orthographic 2D top-down view where the perimeter of the cross section can be traced, showing the shape of the permanent crush. The two vehicles were matched by using the drawings of the maximum permanent crush profile of the two vehicles at the corresponding elevation (*Figure 3*).

Figure 3: Crush Damage Matching (Static)

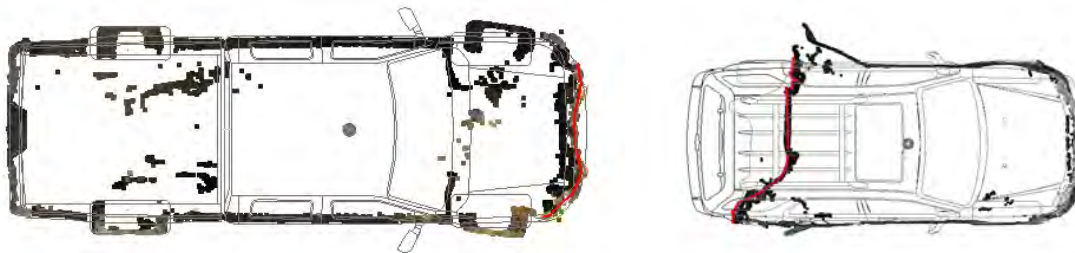
The damage profile was placed over an undamaged vehicle drawing, showing the change in the vehicle's shape (*Figure 4*). This was used to determine the amount of crush on the vehicle. In order to compare the damaged vehicle to an undamaged vehicle, an exemplar Ford F250 was inspected and scanned. The F250 inspected was a stock, unaltered, 2015 Ford F250 Super Duty Crew Cab 4x4 Pickup with LT275/70R18 tires. The exemplar was verified by using the Vehicle Identification Number (VIN). An exemplar Ford Escape, which was also stock and unaltered, was also inspected and scanned. The exemplar Escape was also scanned with an exemplar Safety 1st child seat, positioned in the rear left seat. The exemplar for the Escape was a 2010 Ford Escape 4x2 with the same size tires as the accident vehicle (235/70R16). The Escape exemplar was also verified using the VIN.

Figure 4: Crush lines from scan cross section

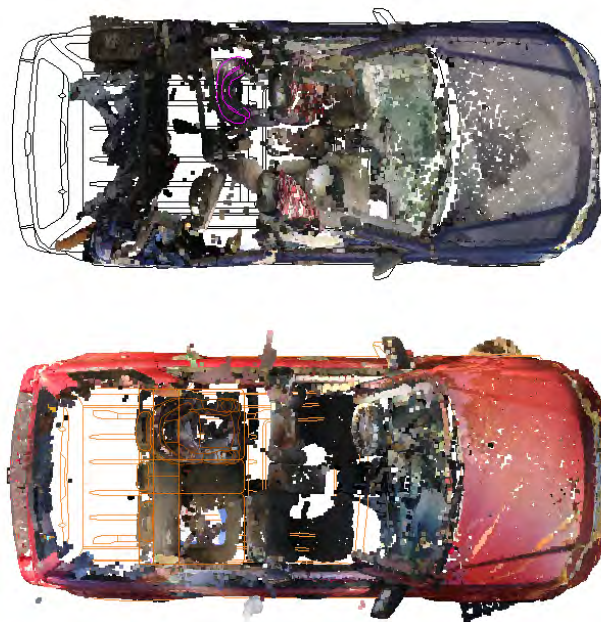
The rear seat of the Escape had been displaced forward significantly. To measure the change in forward distance that the seat had been displaced, the roofs of the subject Escape and the Escape exemplar scans were cropped, revealing the interior of the vehicles. Because the rear seat moved forward, the child seat also moved forward. The exemplar car seat was scanned in the exemplar Escape; therefore, it was visible in the cropped scan. The accident car seat no longer fit in the subject Escape. Using a 3D editing software, CloudCompare, the exemplar car seat was placed in the scan of the accident Escape based on DOA photos. This model was imported into AutoCAD and the roof was cropped, revealing the difference in the forward distance of the child seat. The movement of the head rest area and the bottom of the seat were compared (*Figure 5*).

Figure 5: Rear seat and child seat change in position

- The Escape felt a maximum of near 23.6 g's.
- The left rear occupant position had approximately 1.5 feet of forward static shift and the dynamic shift of the head rest area of the child's seat was approximately 2 feet.

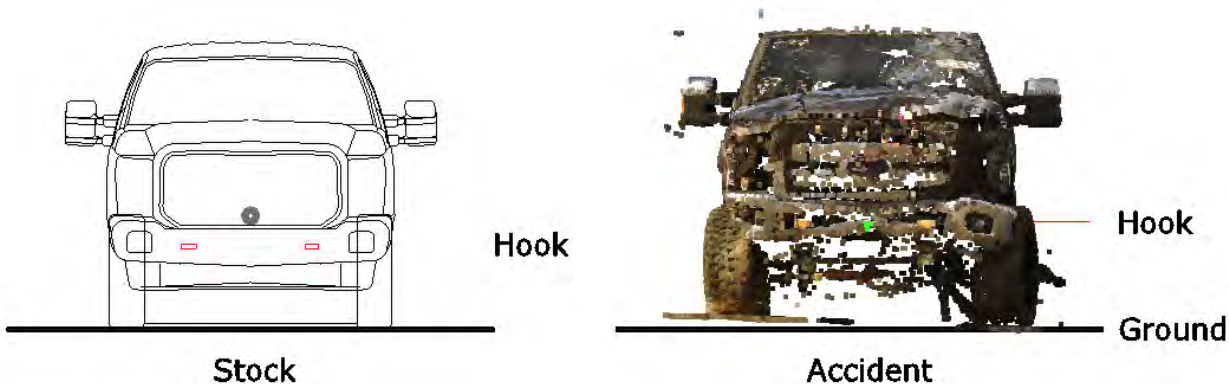
The difference in height of the F250 was determined by using side views of the F250 in AutoCAD. The scan of the exemplar (stock) F250 was drawn and the subject F250 was drawn. This revealed the height difference between the stock and lifted F250 (*Figure 6*). This was also verified by using measurements of the subject F250 and comparing against the exemplar F250.

Figure 6: Stock F250 comparison to Accident F250

- The F250 was effectively lifted over 6 inches.
- In the subject accident the F250 bumper penetrated to beyond the original location of the child seat pushing the child seat's head rest area (Safety 1st logo) forward by over 18 inches to a post-crash rest location of 1.1 feet from the rear of the driver's static seat back location.
- Dynamic analysis and damage matching reveal that during the crash the F250 bumper penetrated 4.36 feet into the rear hatch trunk and rear seat position areas, pushing the child seat's head rest area (Safety 1st logo) forward over 2 feet to a during-crash location only about 6 inches from the driver's static seat back location (top of the seat).
- Had the lift kit not been installed, the stock F250 would have interacted more directly with the stronger structural components of the Escape rear as opposed to the Escape hatch and pillars.

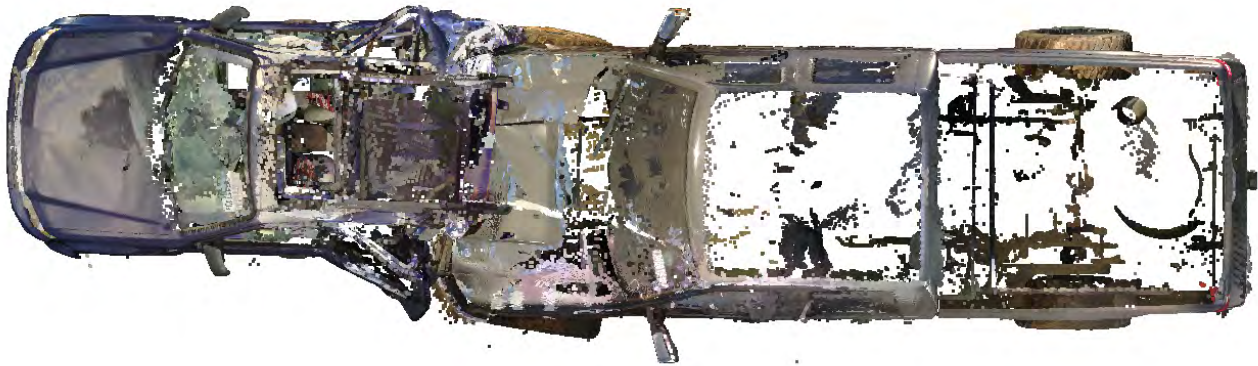
Escape displayed contact evidence. Based on the measurements, shape, and size of the markings, revealing that this was a match point. In CloudCompare, the two vehicles were matched together based on these two marks (*Figure 7*). Another match point was where the tow hooks of the F250 impacted the rear hatch of the Escape. The F250 has two tow hooks that are located near the center of the bumper. The Escape had a hole immediately to the left side of the bottom of the rear hatch and another hole that was near the right side of the centerline of the vehicle. The analysis revealed that the F250 tow hooks matched the holes of the Escape. Additional match points increased the certainty of the model.

Figure 7: Maximum Engagement modeled in 3D

- The damage on the Escape matches the F250 damage and features.
- Holes on the F250's hood were created by the hinges on the Escape's hatch that hold the rear windshield in place.
